Long Term Maintenance Plan (LTMP) 2012 - 2026

Body Corporate 169774

2 Alpers Avenue,
Epsom, Auckland

Opus International Consultants (PCA) Limited

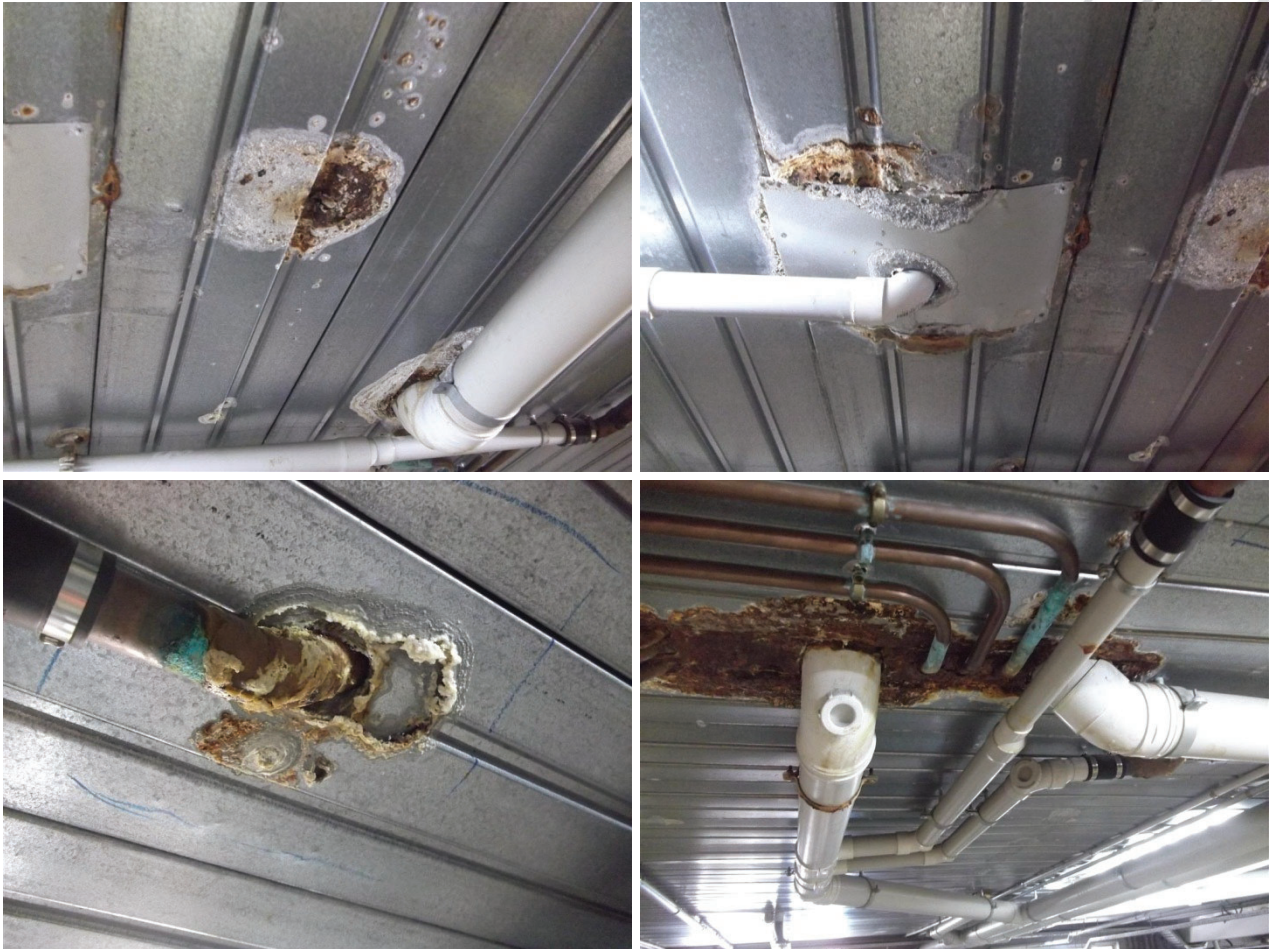
During the inspection it was noted that sections of the steel deck system contained corrosion and galvanic corrosion. These types of corrosion can affect the strength of the steel deck system and concrete floor. We recommend a detailed inspection by a suitably qualified person to identify the source and remedy.

In the garage it was noted that sections of the steel deck system contained corrosion and galvanic corrosion. These types of corrosion can affect the strength of the steel deck system and concrete floor. We have allowed a PC sum to allow for a detailed inspection by a suitably qualified person to identify the source.

Year	Element	Description	Estimate in (\$)
2012	Carpentry	Allowance for Investigation into corrosion located to steel deck in Garages.	\$10,000
2012	Interior Lighting	Replacement of obsolete lighting fittings in garage.	\$3,840
2014	Exterior painting	Repainting of building's exterior.	\$73,805
2014	Exterior Lighting	Replacement of exterior light fittings; PIR motion sensor, fluorescent and bulkheads.	\$6,190
2014	Paving	Repainting of carpark lines and numbers.	\$620
2014	Carpentry	Replacement of door closers.	\$750
2014	Electrical	Replacement of gate controls, gate motor and garage door openers	\$8,700
2014	Heating and ventilation	Replacement of ceiling extract fan in Bathroom of Managers Office.	\$500
2014	Lift	Refurbishment of interior of Lift car.	\$10,000
2014	Security	Replacement of security components; intercom/door release and mag locks.	\$1,250
2016	Cladding / windows / doors	Allowance for repairs to seals and hinges and garage door sills.	\$1,600

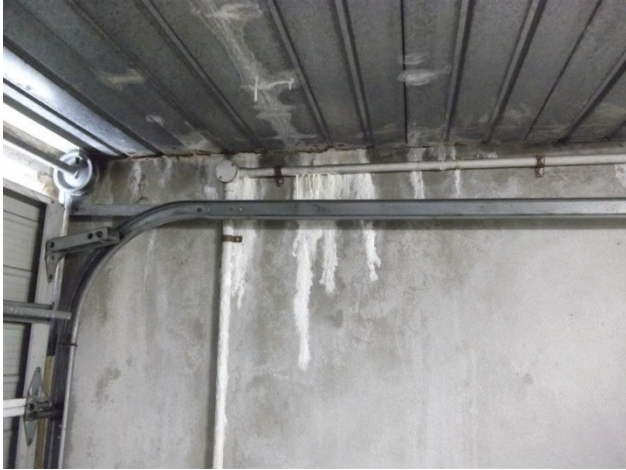
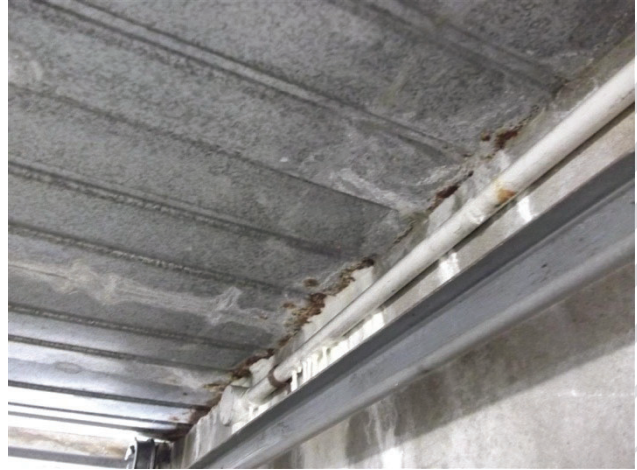
It was noted that the North concrete wall within the North Carpark contained efflorescence, efflorescence is a sign that the membrane has failed and water is flowing through the concrete. We recommend a detailed inspection by a suitably qualified person to identify the source and remedy.

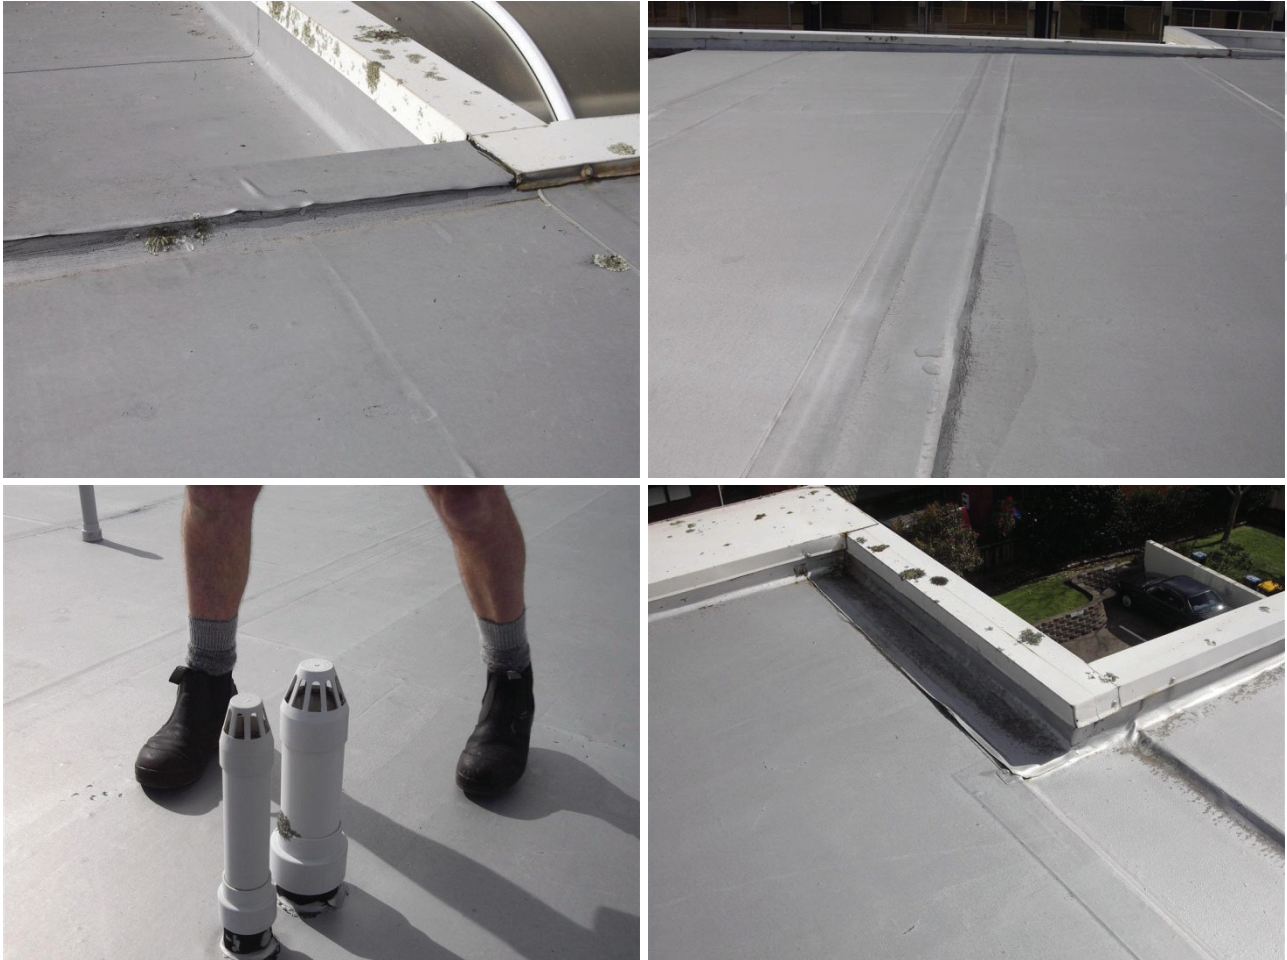
Figure 1 - Grey roof membrane

The visual inspection of the roof noted the roofing is of a grey membrane with internal membrane gutters. The roof was generally observed to be in a fair condition. However, we noted that there were areas of the membrane that was lifting, roof penetrations that were poorly made, minimum or no upstands to parapet wall and poor roof falls. We recommend considering minor repairs to the membrane to prolong the life of the product and to prevent potential issues with water ingress. We have allowed replacement of the membrane in 2016. We recommend monitoring the issues and bringing forward the replacement date if required.

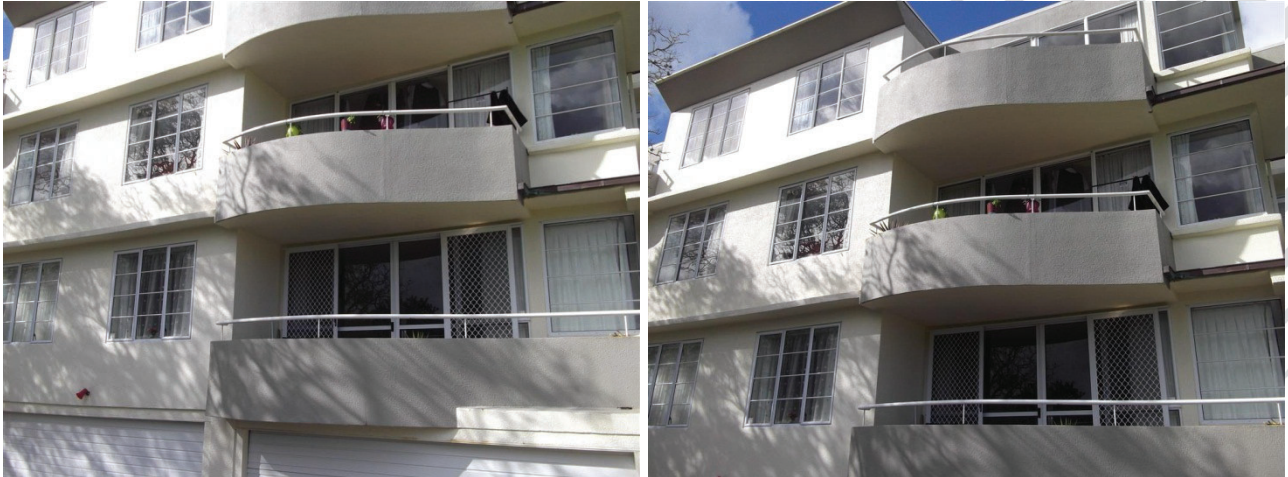
The cladding is concrete walls with a textured plastered finish. The cladding appears in sound condition no allowance has been made within the life of the plan for replacement work other than maintenance painting.

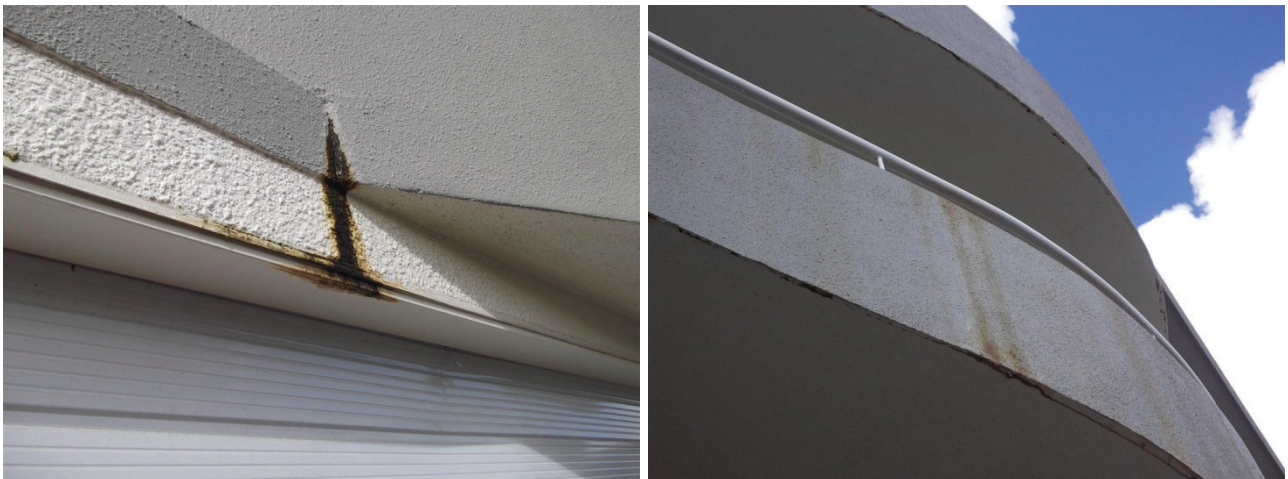
Figure 3 - Water ingress through decks

During the survey it was observed that there are a number of decks showing signs of water ingress with water flowing out the bottom of the parapet and staining the deck below. This is potentially due to the waterproof barrier failing and/or poor drainage to the deck. We recommend a detailed inspection by a suitably qualified person to identify the source. We have not included this within the plan as the decks are within the individual Unit boundaries and therefore the responsibility of the owners.

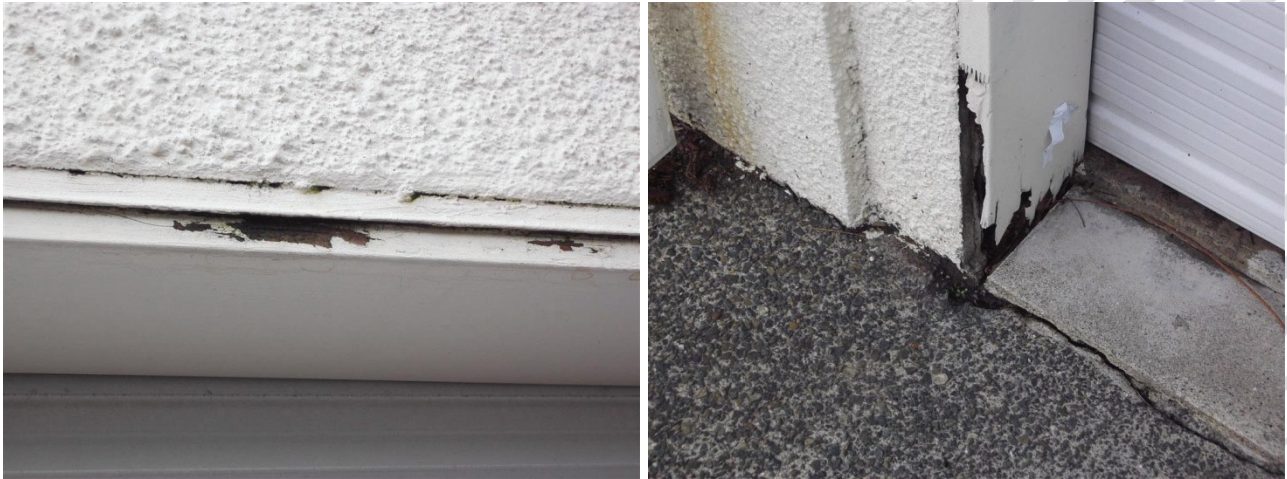
Figure 4 - Decay to Garage door sills

It was noted that a number of the garage door sill were decaying. We have allowed a sum to replace the affected areas in 2012.

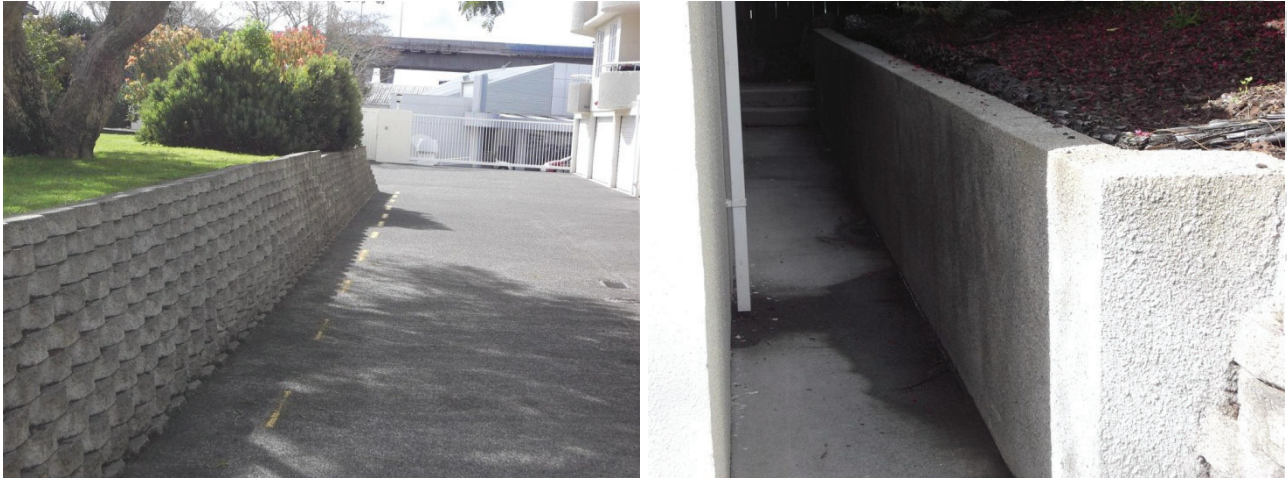
The site was paved in concrete and was observed to be in a satisfactory condition. We have allowed replacement in 2049.

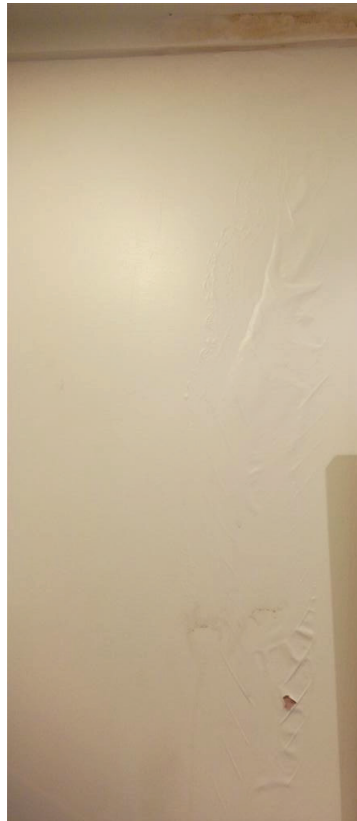
Figure 5 - Water ingress in Managers Office

During the survey it was noted that a wall in the Managers Office Bathroom showed signs of water ingress or a water leak. We recommend a detailed inspection by a suitably qualified person to identify the source and remedy.

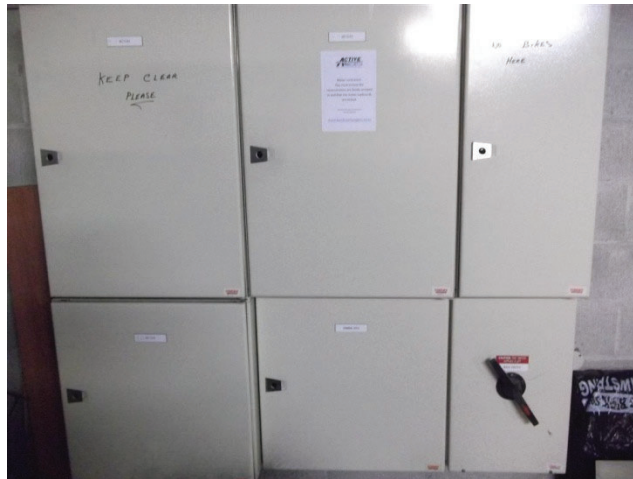
Figure 6 - Main building switchboard

The main building switchboard is located within the North garage. From a visual inspection the board appears to be in a satisfactory condition. Replacement of the switchboard has been allowed for in 2029.

As both good practice and to maintain safety within the building we would recommend that all switchboards are scanned with a thermal imager annually to detect loose connections which are a significant cause of electrical fires.

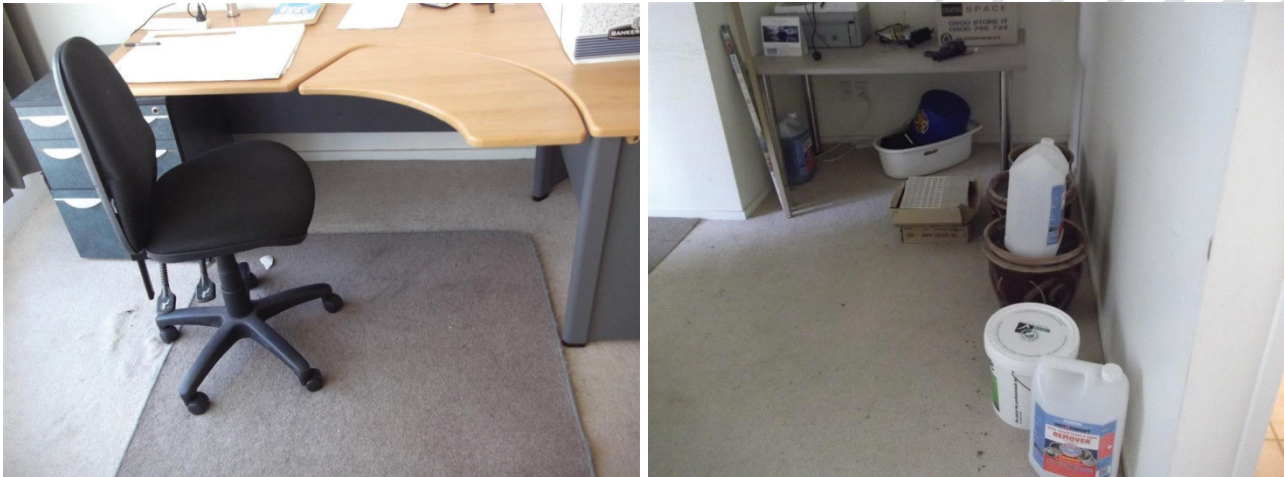
Figure 7 - Flooring to Managers Office

The internal floor covering in the Managers Office is of carpet and tiles to the bathroom. The tiles were observed to be in satisfactory condition and we have allowed replacement in 2024. The carpet requires re-stretching and contained areas of staining. We have allowed replacement in 2020.

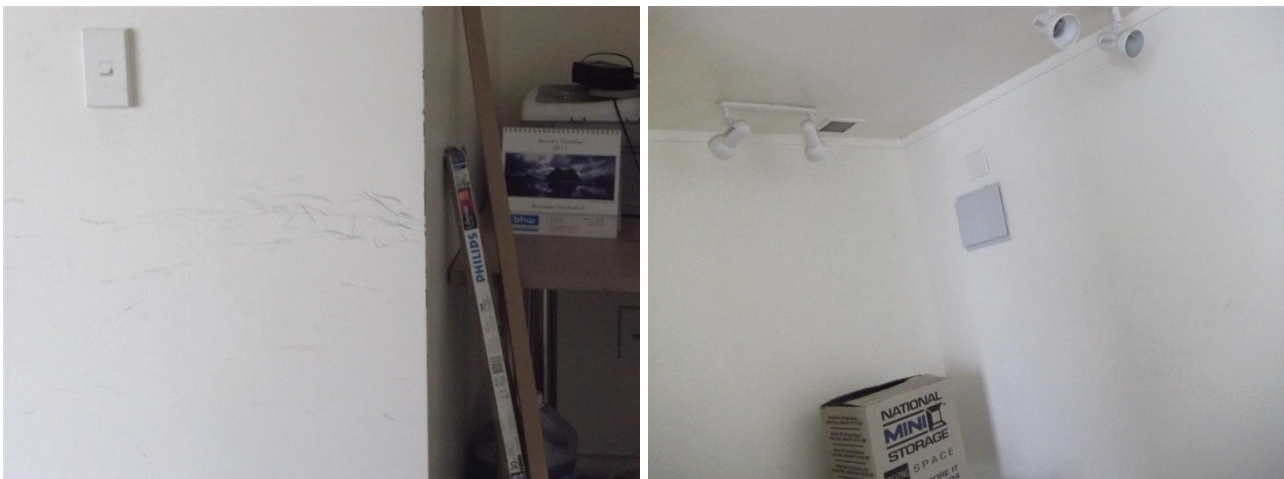
Figure 8 - Managers Office paintwork

The paintwork to the buildings internal areas is generally in fair condition with only some minor scrapes and areas of impact damage. We have allowed for the Unit to be repainted in 2016.

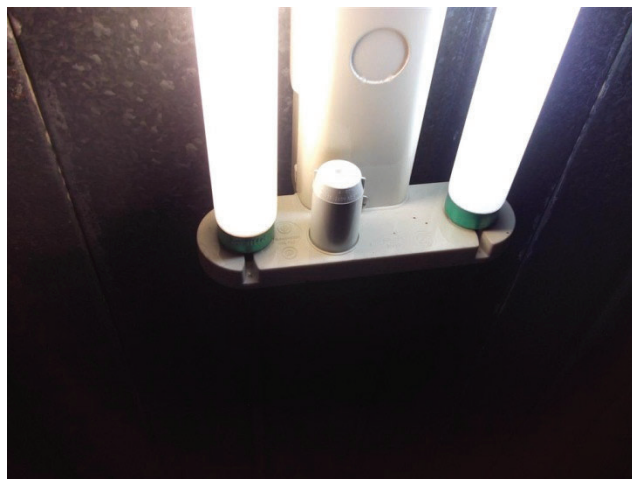
We noted that the fluorescent fittings in the garages were obsolete and unsafe, please see appendix C. We have allowed replacement of these fittings in 2012.

Figure 9 - Obsolete light fittings in Garages

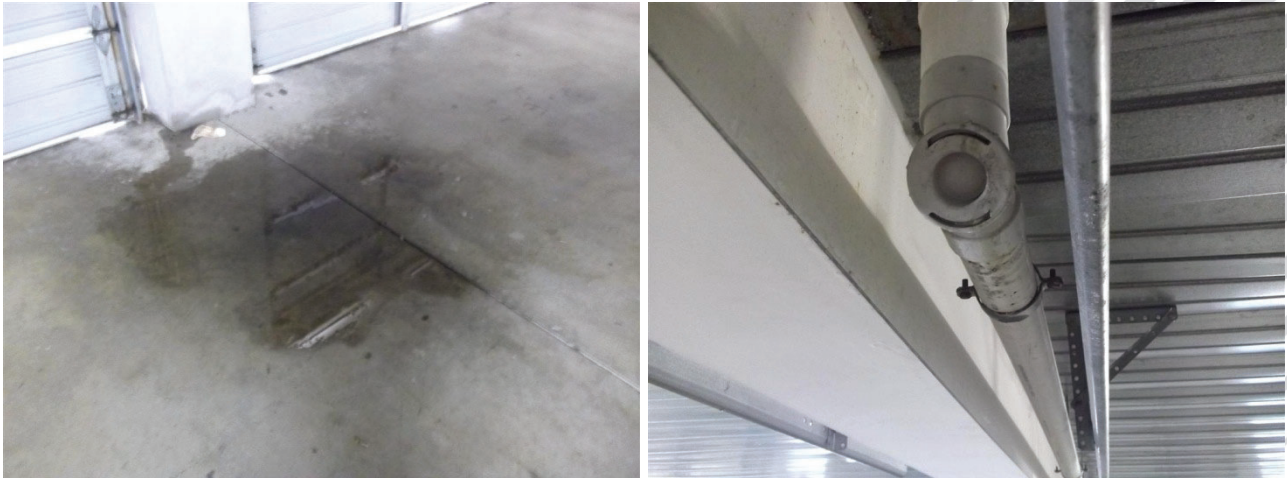
Figure 10 - Leaking pipework in Garage

At the time of inspection a minor leak was noted to a section of pipework to the North Garage. This will need to be addressed immediately by a suitably qualified person to repair the leak.

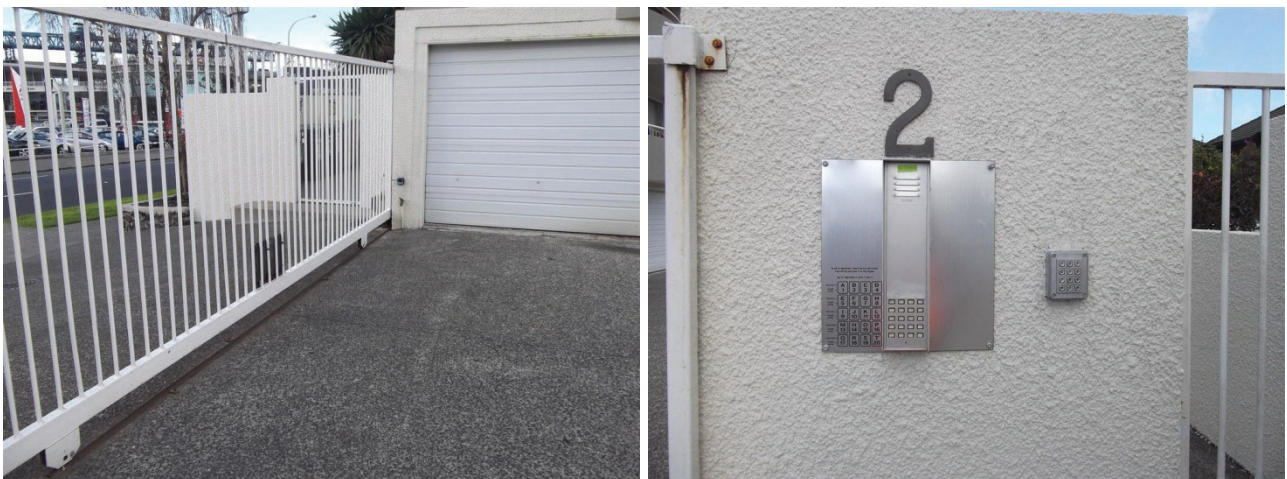
Figure 11 - Vehicle entrance and key pads

The property access on foot and vehicle is via the entrance on Alpers Avenue. Painted steel gates are used for security and access to residents is via key pad technology. Visitors to the building can obtain access by key pad contact with the relevant Apartment. This system has been included within this plan and replacement has been allowed for in 2014.
