Thermal Imaging Inspection

5B Domett Avenue, Epsom

Prepared By:	HS BUILDING INSPECTIONS	Customer / Client:	Glen Ogilvie
Inspectors Name:	Graham Walton	Prepared For:	*****
Date:	28/07/2022 & 13/10/2022	Address:	5B Domett Avenue, Epsom
Time:	13:00 (12 GMT)	Email:	
		Contact:

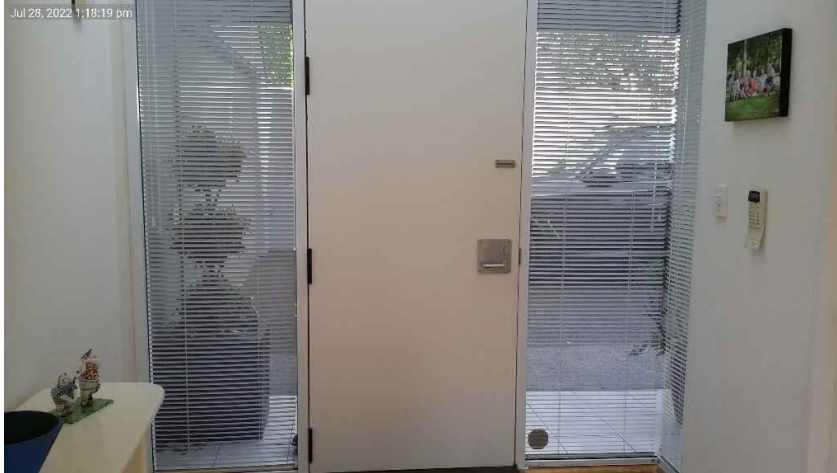
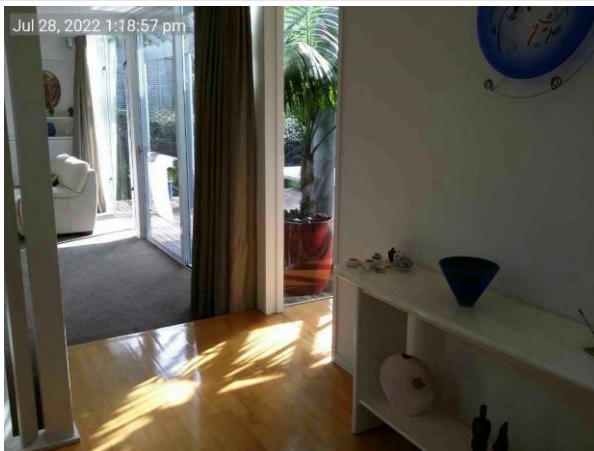
ENTRANCE

No elevated moisture readings detected at time of inspection other than notes. All moisture readings were normal 0-18% moisture.

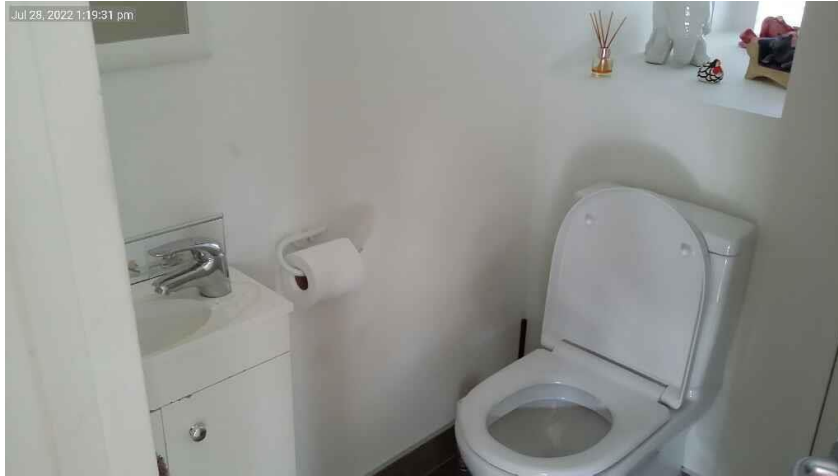
POWDER ROOM

No elevated moisture readings detected at time of inspection other than notes. All moisture readings were normal 0-18% moisture.

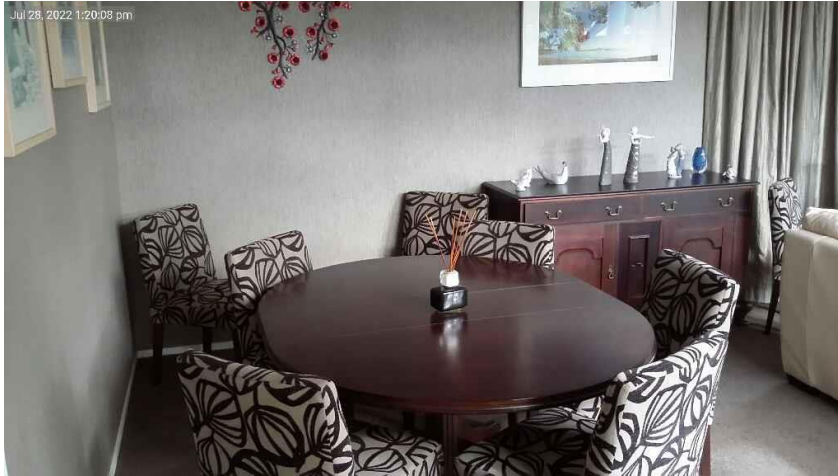
DINING ROOM

No elevated moisture readings detected at time of inspection other than notes. All moisture readings were normal 0-18% moisture.

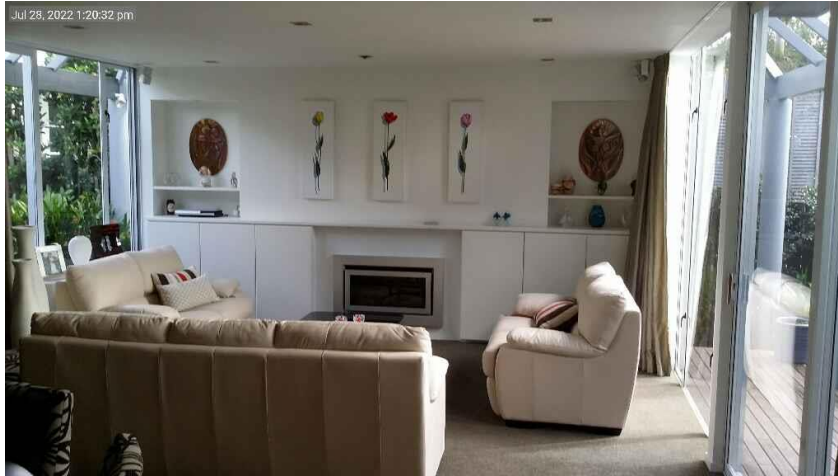
LOUNGE

No elevated moisture readings detected at time of inspection other than notes. All moisture readings were normal 0-18% moisture.

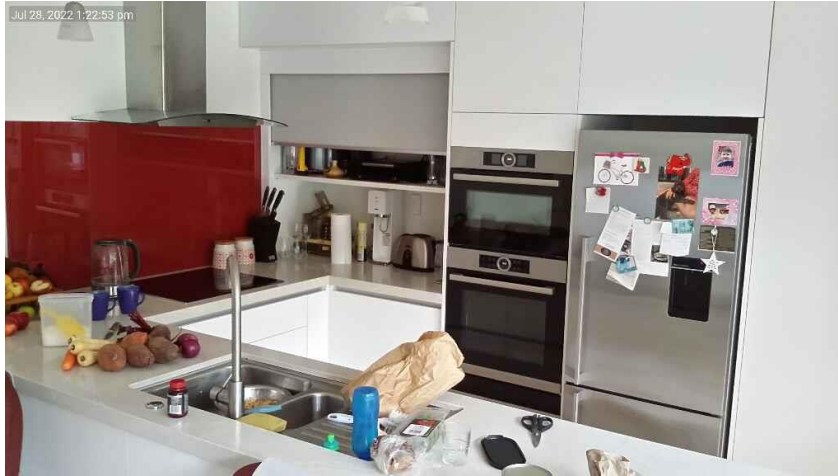
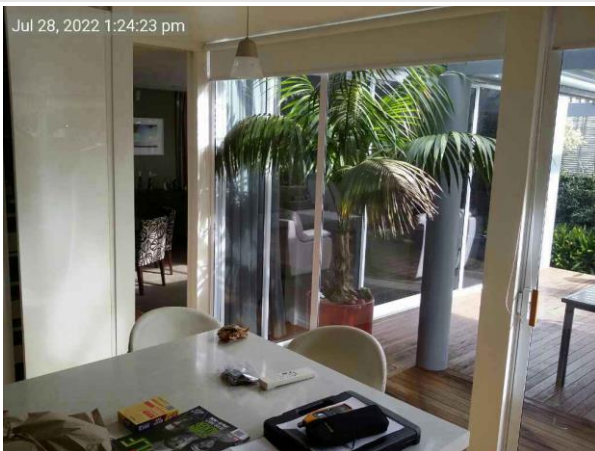
KITCHEN

No elevated moisture readings detected at time of inspection other than notes. All moisture readings were normal 0-18% moisture.

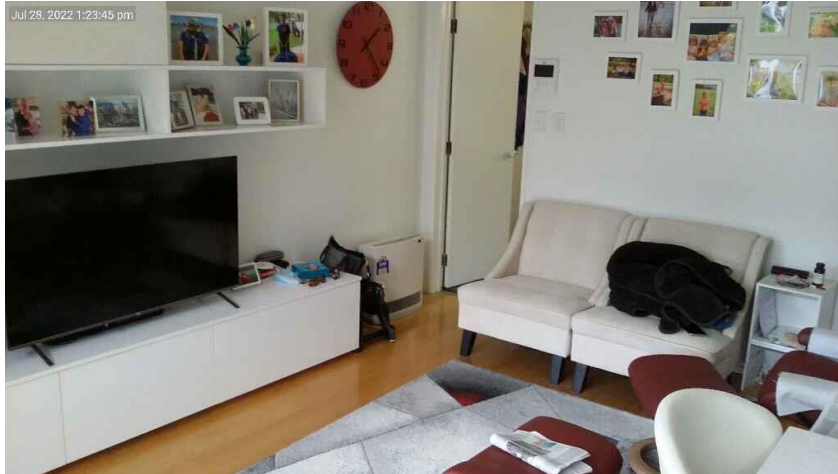
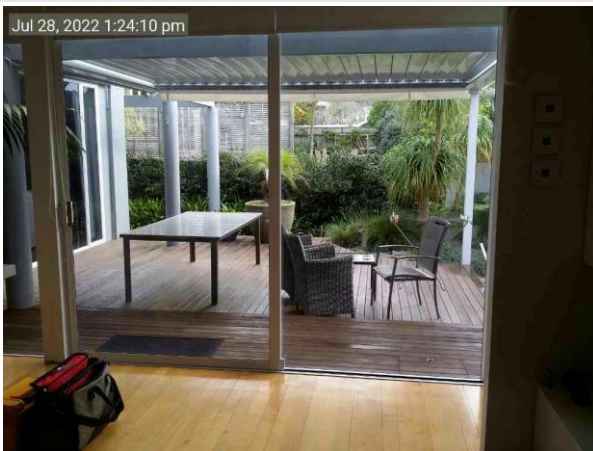
FAMILY ROOM

No elevated moisture readings detected at time of inspection other than notes. All moisture readings were normal 0-18% moisture.

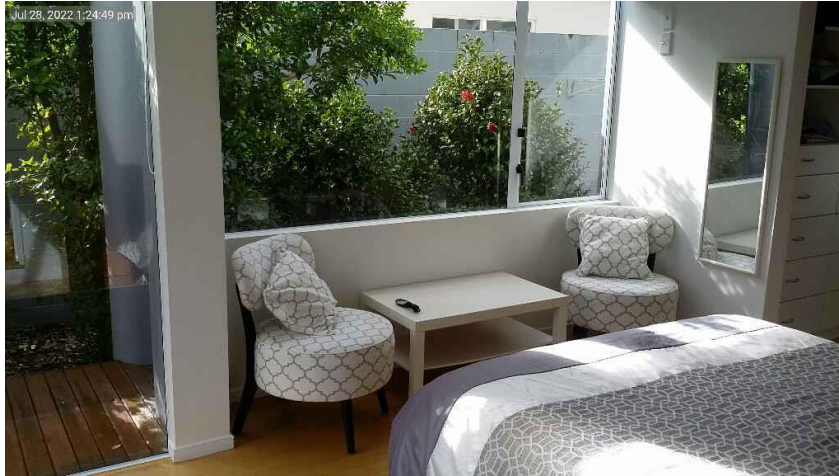
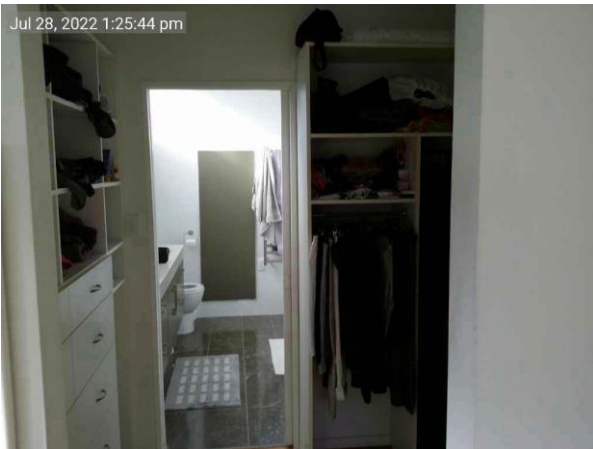
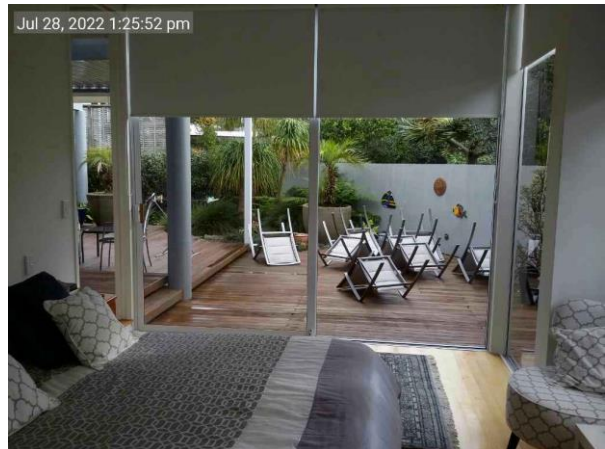
PRIMARY BEDROOM

No elevated moisture readings detected at time of inspection other than notes. All moisture readings were normal 0-18% moisture.

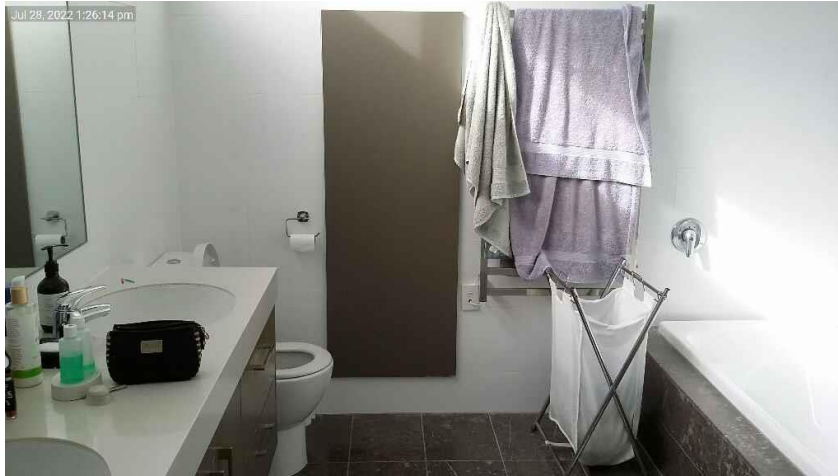
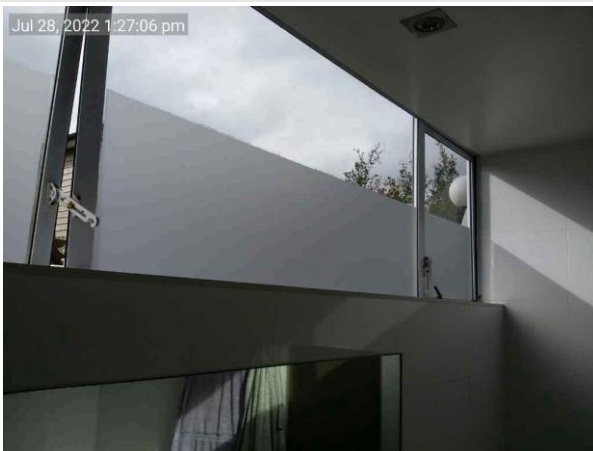
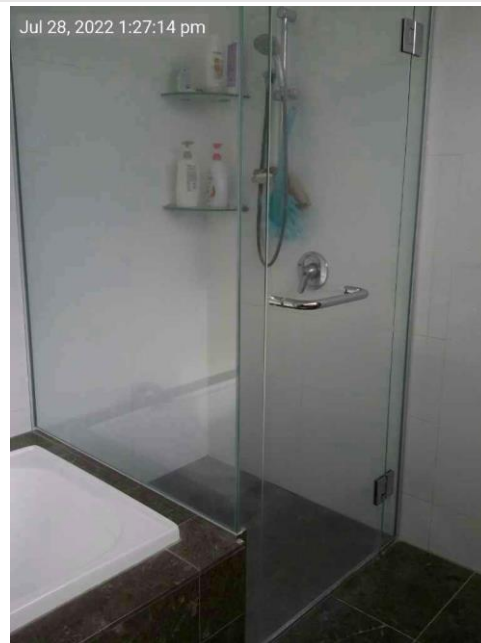
ENSUITE

No elevated moisture readings detected at time of inspection other than notes. All moisture readings were normal 0-18% moisture.

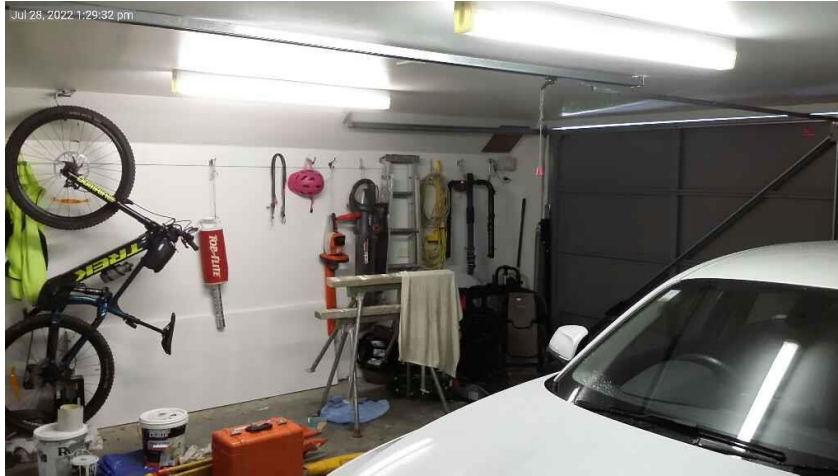
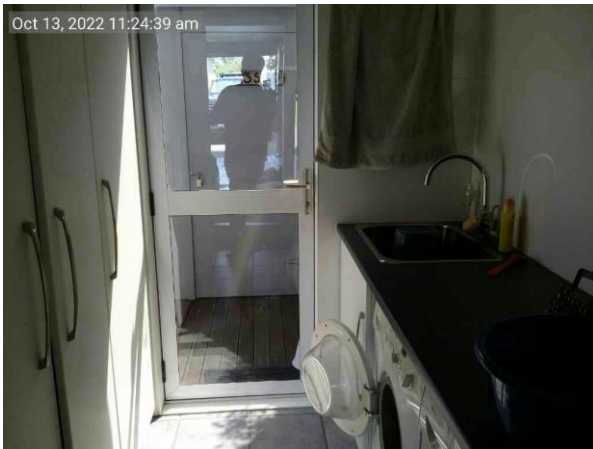
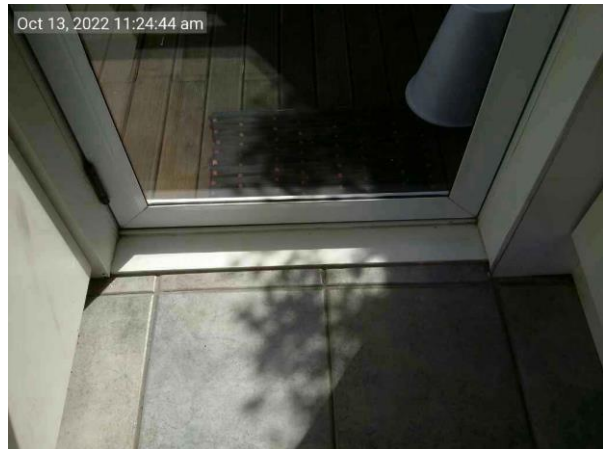
GARAGE / LAUNDRY

No elevated moisture readings detected at time of inspection other than notes. All moisture readings were normal 0-18% moisture.

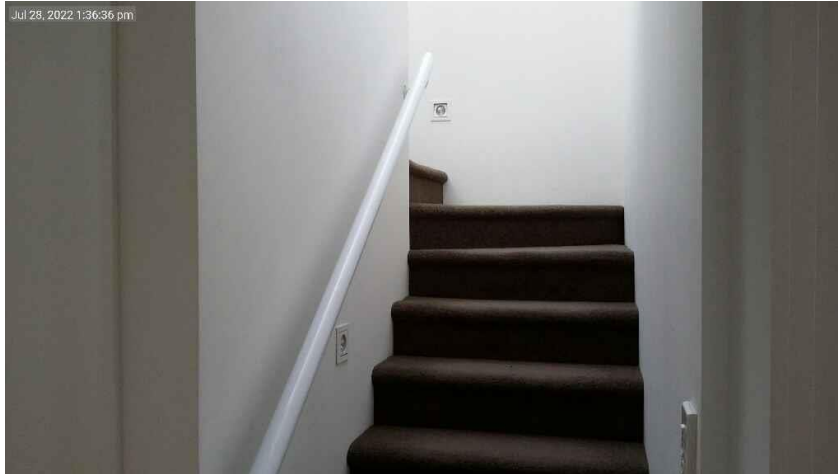
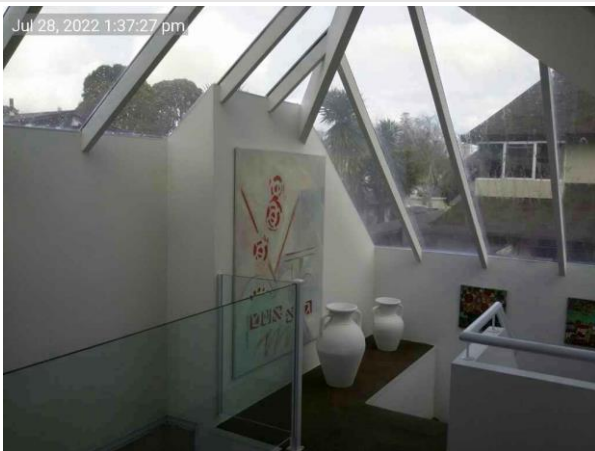
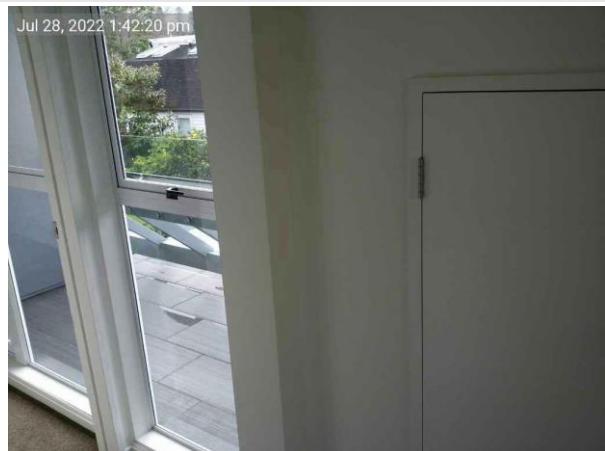
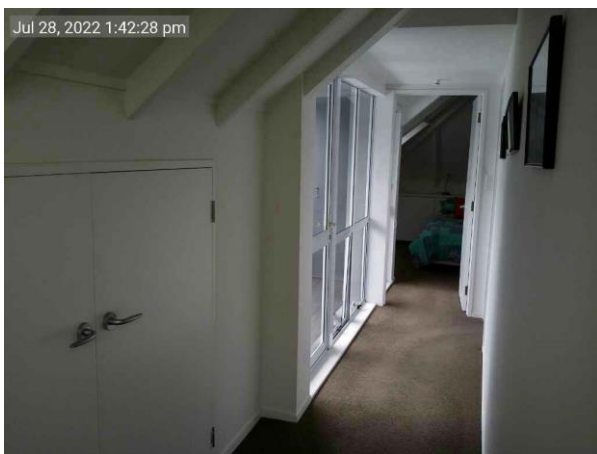
STAIRS / LANDING

No elevated moisture readings detected at time of inspection other than notes. All moisture readings were normal 0-18% moisture.

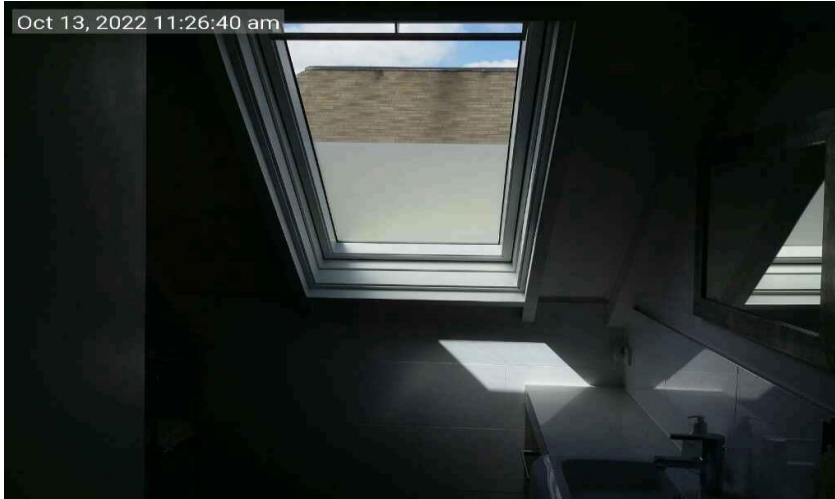
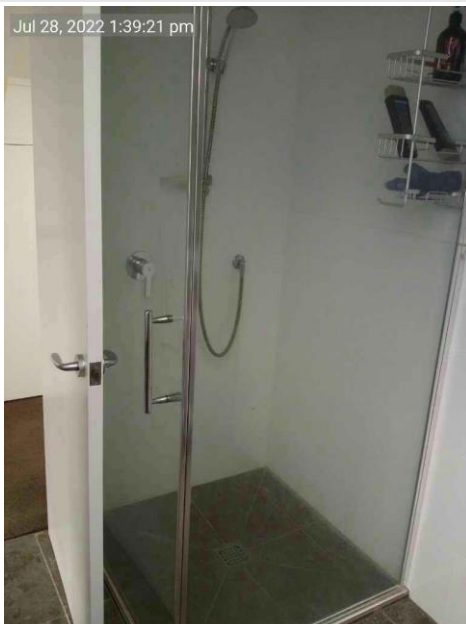
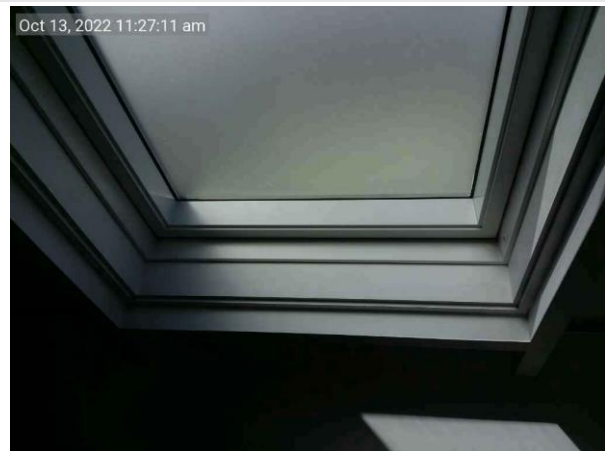
BATHROOM

No elevated moisture readings detected at time of inspection other than notes. All moisture readings were normal 0-18% moisture.

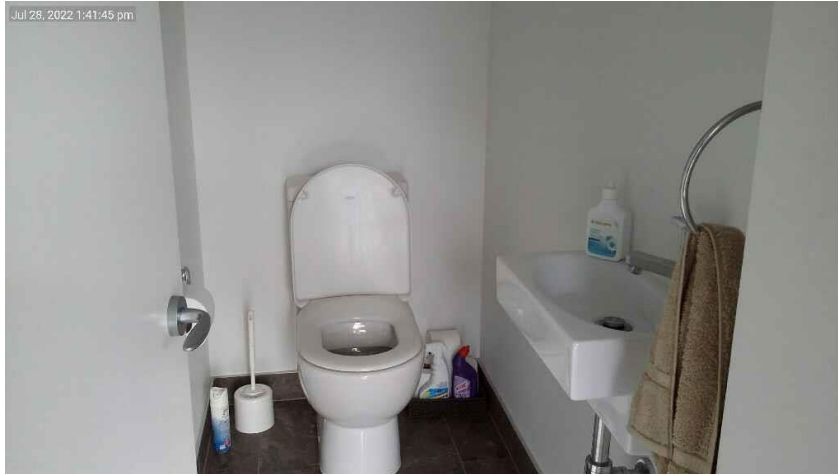
POWDER ROOM

No elevated moisture readings detected at time of inspection other than notes. All moisture readings were normal 0-18% moisture.

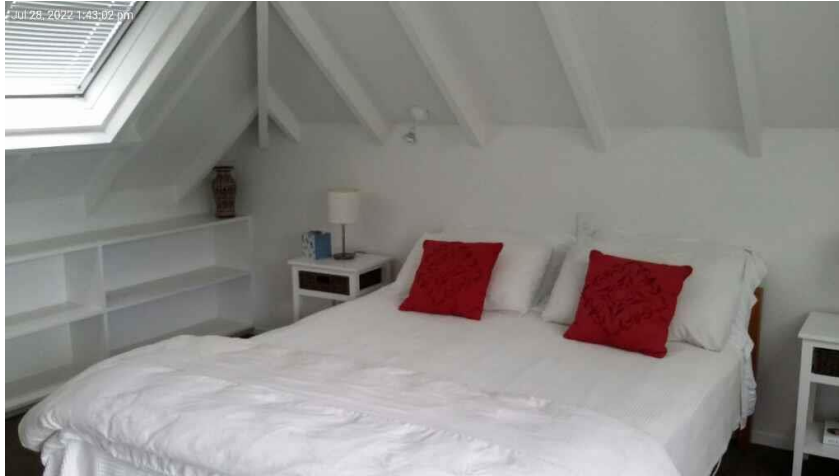
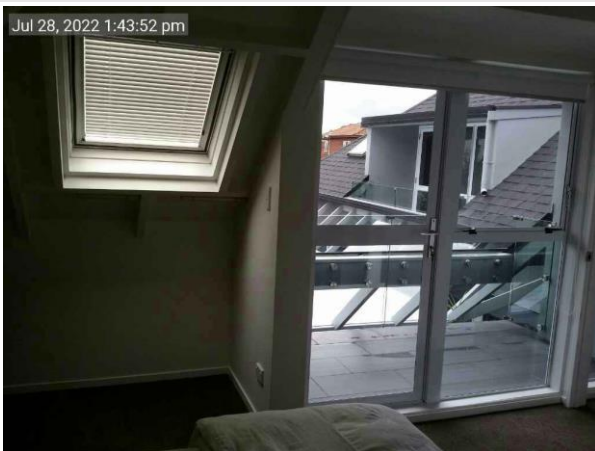
BEDROOM 2

No elevated moisture readings detected at time of inspection other than notes. All moisture readings were normal 0-18% moisture.

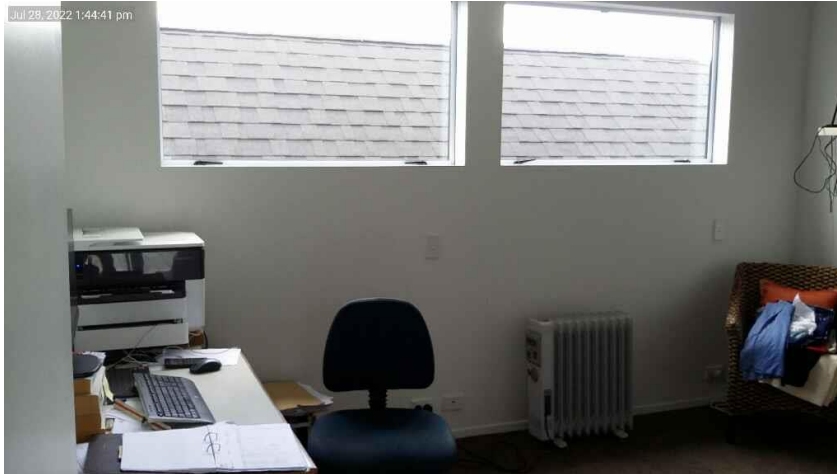
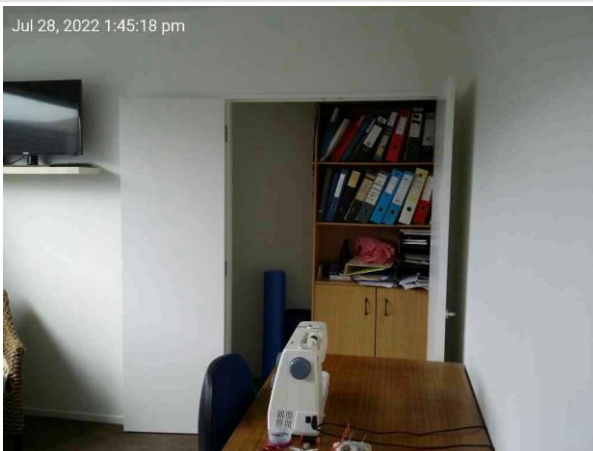
OFFICE

No elevated moisture readings detected at time of inspection other than notes. All moisture readings were normal 0-18% moisture.

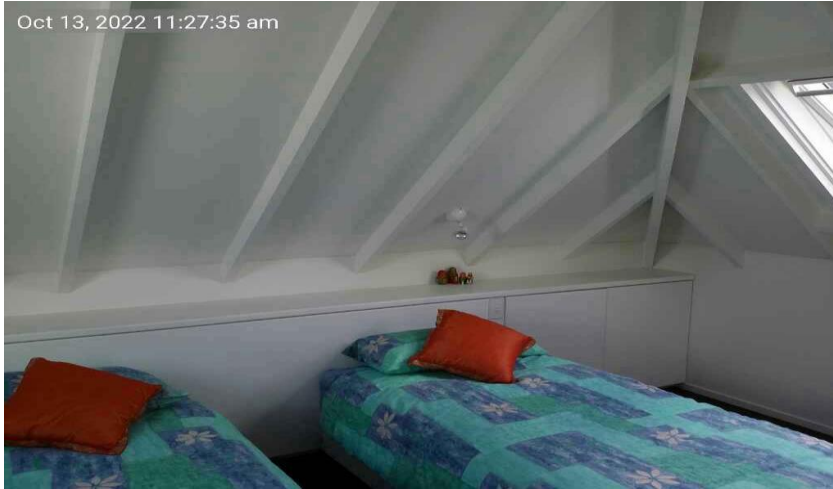
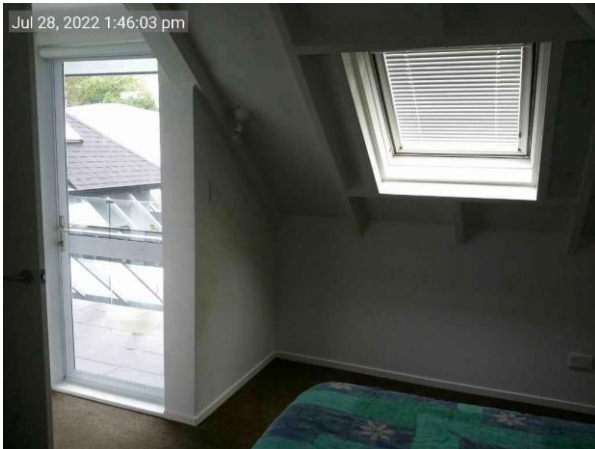
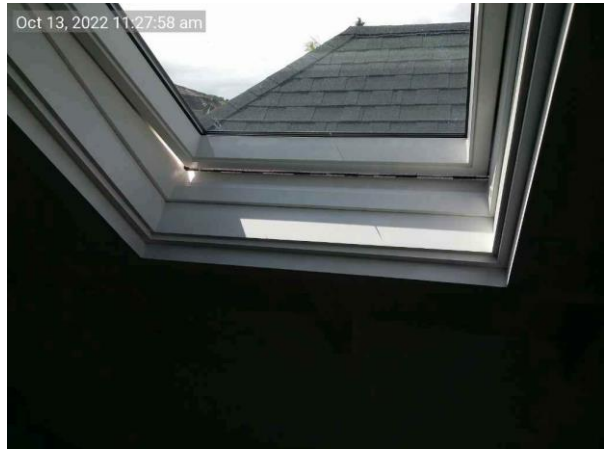
BEDROOM 3

No elevated moisture readings detected at time of inspection other than notes. All moisture readings were normal 0-18% moisture.
