GEOTECHNICAL INVESTIGATION REPOR

# PROPOSED NEW TWO-STOREY **DWELLING**

**58 TE KAWA ROAD GREENLANE**

Reference: GM1557

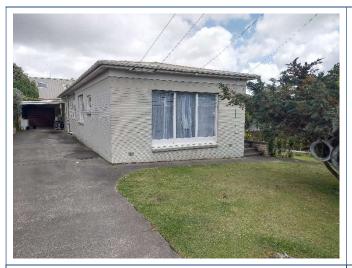
#### Photograph 1:

Looking northwest toward the existing dwelling and driveway from Te Kawa Road.

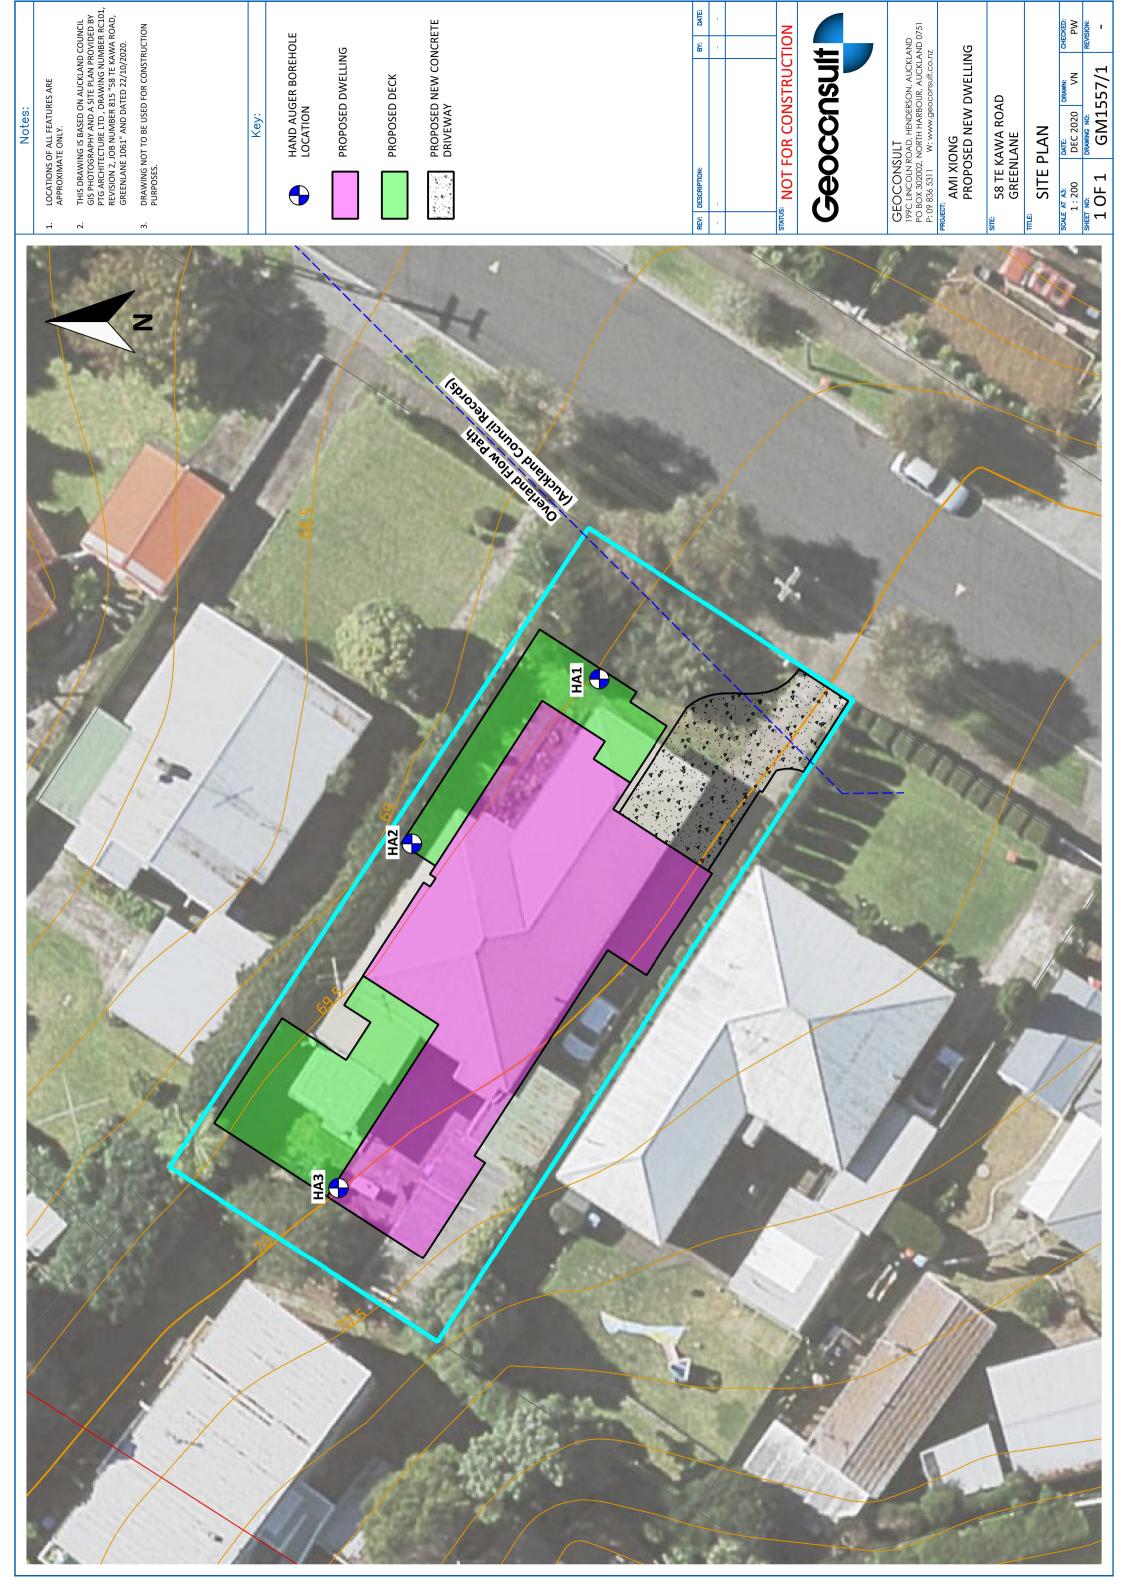
Drawing Number: GM1557/1

A site plan is attached, drawing number GM1557/1.

The approximate location of the proposed dwelling is shown on the attached site plan drawing number GM1557/1.

The approximate locations of the boreholes are shown on our attached site plan drawing number GM1557/1. The borehole logs and Scala Penetrometer test results are also attached. The soil descriptions given on the logs are in general accordance with the New Zealand Geotechnical Society's "Field Description of Soil and Rock." The undrained shear strength values given on the logs are 'Shear Vane Strengths', factored in accordance with the New Zealand Geotechnical Society Guidelines, not direct readings from the shear vane dial. The groundwater levels were measured following drilling and are indicated on the borehole logs.
