# Healthy Homes Standards Compliance Inspection

Required by Residential Tenancies Regulation 2019

**25A Selwyn Road, Epsom**

12/03/2025

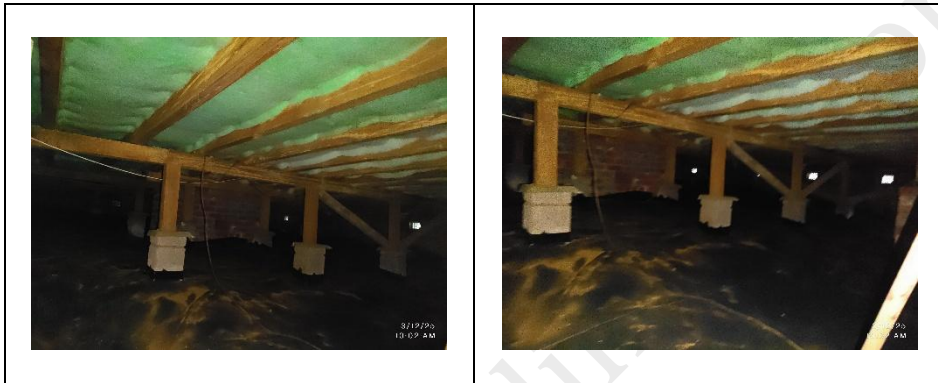
**Type:** Polyester

**R-Value:** 1.5

**Thickness:** 100 mm

**NOTES:** Current insulation was installed correctly throughout the underfloor cavity. R-Value is greater than 1.3 (1.5 in this case). No action is required.

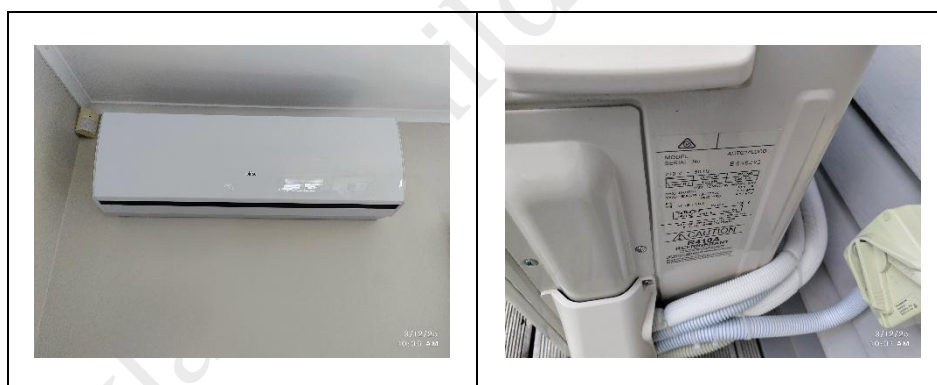
Required Output: **4.3 kW**

Current Output: **5.4 kW**

Heat Pump Model: **Fujitsu AOTG14LUCB**

NOTES: As per the living room floor area, the existing fixed heater generates a heating output higher than the required amount. No action is required.

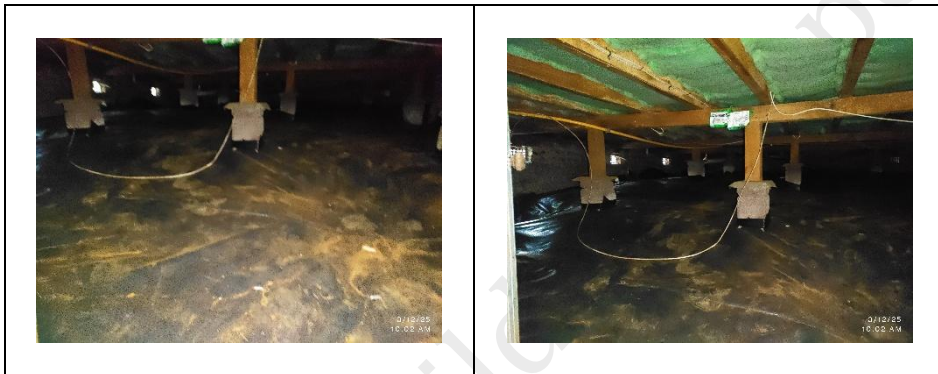
NOTES: Under the new moisture and ingress standards for Healthy Homes, all enclosed subfloor cavities must have a Ground vapour barrier film installed. GVB installed under the property as per NZBC. No action is required.

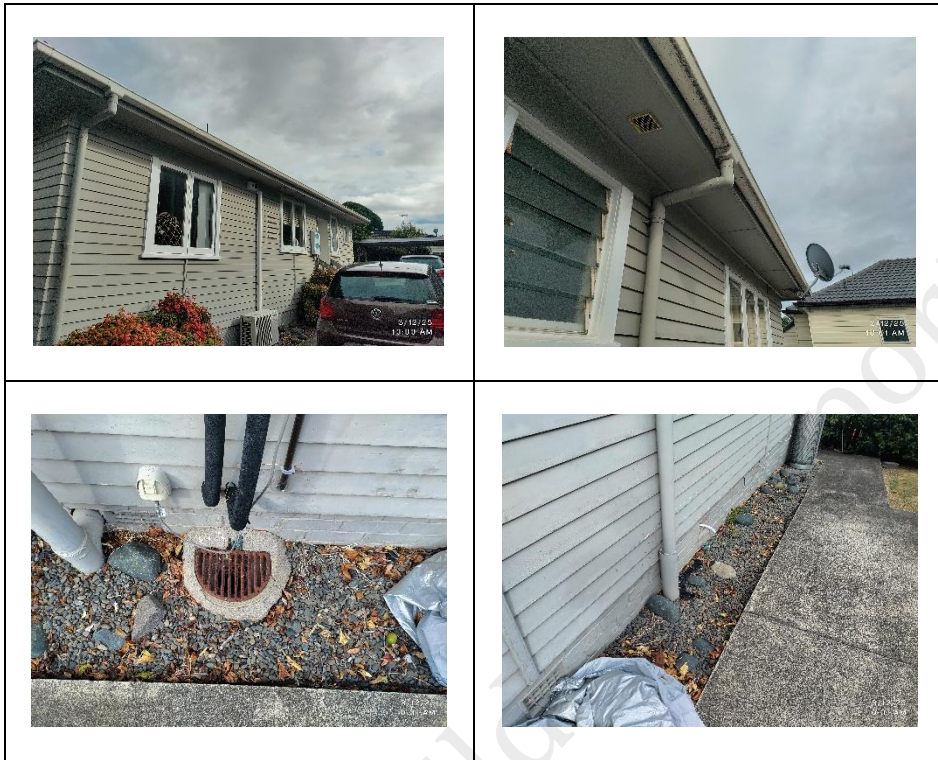
Photos of ground surface drainage:

NOTE: All water drainage pipes observed to be flowing correctly at the time of inspection. No action required.
