**SOAKHOLE DESCRIPTION:** Existing Soak Hole

## 5.2 New Soakage Investigation

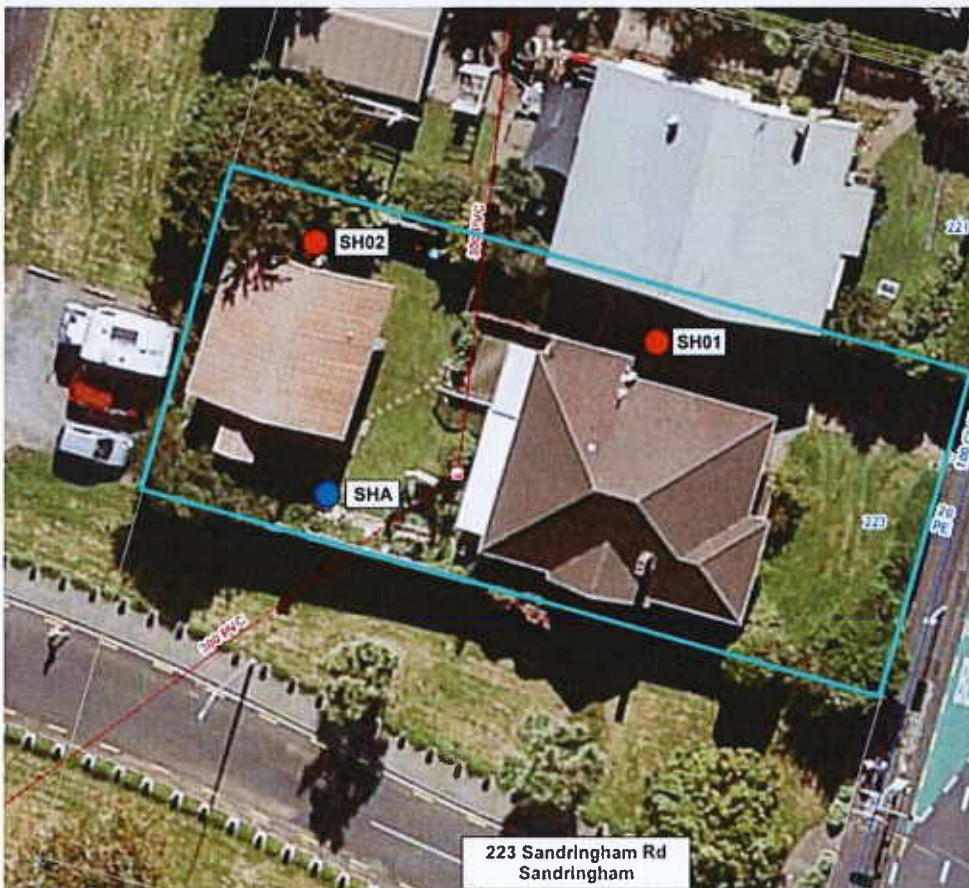
**SOAKHOLE ID #:** **SHA**

**SOAKHOLE LOCATION:** 10.0m rear boundary & 2.5m from left boundary

**TYPE OF LID:** Round steel

**SOAKHOLE DIAMETER:** 1.2m

**DEPTH:** 1.4m

**TYPE OF CONSTRUCTION:** Pre-cast concrete

**BOREHOLES:** YES      **NO & DIA:** 1 x 100mm

**SYPHONS:** YES      **NO & DIA:** 1 x 100mm

**TOTAL LITRES:** 9,700L      **OVER 10 MINS: 16.1L/sec**  
Full Delivery Flow

**NOTES:** New syphon installed

truck was carried out for over a 10-minute test period, returning a flow rate of 16.1 L/s. The existing soakhole capacity is summarised in Table 3.
